IN RE: ETHICON, INC., PELVIC REPAIR SYSTEM PRODUCTS LIABILITY LITIGATION

Master File No. 2:12-MD-02327

RULE 26 EXPERT REPORT OF HOWARD JORDI, PhD

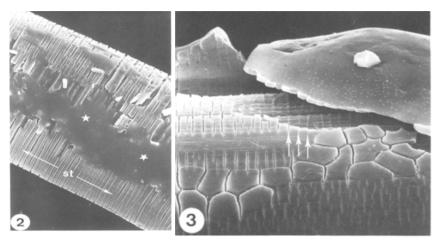
implantation "[b]oth prolene loops showed severe degradation of the surface layer."⁴⁰ The researchers characterize the morphological features on the surface of several explanted fibers and distinguish very well the different features of biological deposits compared to those associated with degraded Prolene polypropylene.

Figure 1- Prolene: Figure 2 (370×), degraded surface; *=deposited organic matter; st=regular pattern of striations. Figure 3 (770×), detail of degraded surface layer. ⁴¹

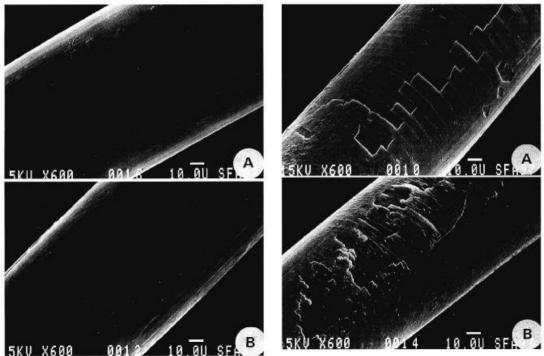
Figure 6. Scanning electron photomicrographs of retrieved and cleaned 6–0 polyvinylidene fluoride sutures showing the surface morphology after implantation for 1 (A, \times 600) and 2 (B, \times 600) years in the

Figure 7. Scanning electron photomicrographs of retrieved and cleaned 6–0 polypropylene sutures showing the surface morphology after implantation for 1 (A, ×100) and 2 (B, ×600) years *in vivo*.

After 1 and 2 years of implantation the surface of the retrieved and cleaned PVDF sutures did not appear to be substantially modified (fig 6). In contrast, the <u>polypropylene</u> <u>sutures explanted 1 and 2 years postoperatively showed evidence of surface deterioration, characterized by uniformly spaced circumferential cracking and <u>peeling and flaking of the polymer material in the outermost surface layer</u> (fig. 7) (emphasis added)</u>

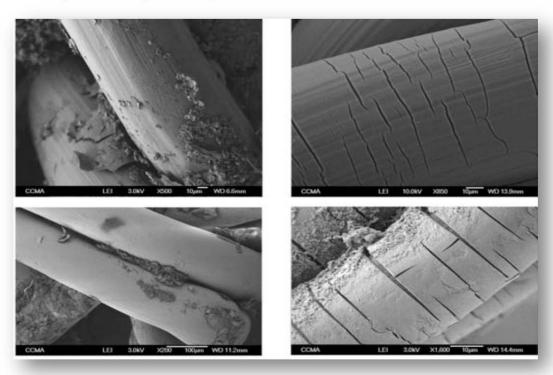
Figure 3- Scanning electron micrograph of heavy weight polypropylene from a pristine Composix E/X mesh. Figure 6. Scanning electron micrograph of heavy weight polypropylene from an explanted Kugel Composix mesh (specimen 2, which remained in vivo for an additional 5 months compared with specimen 1). ⁴⁸

Figure 4- SEM comparison between intact and degraded explants.⁴⁹

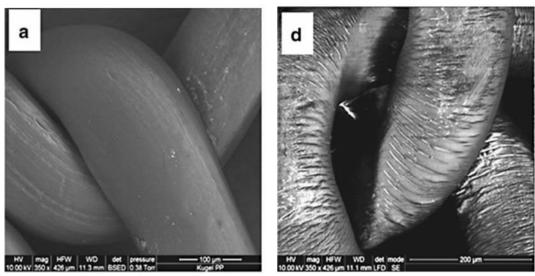
In 2013, Wood *et al.*⁵⁰ published their data from their analysis of an explanted polypropylene mesh device. Using Scanning Electron Microscopy, these scientists found that the explanted polypropylene mesh fibers (d below) were cracked while the pristine, unused polypropylene fibers of the same product (a below) were smooth:

Figure 5- SEM images of pristine (a) polypropylene hernia mesh as well as explanted (d) polypropylene hernia mesh.⁵¹

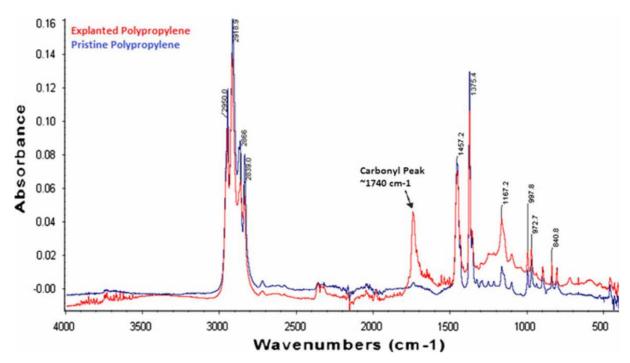
To determine why the polypropylene had cracked, these scientists used FTIR. Wood *et al.* concluded that the cracked surface of the explanted polypropylene mesh was caused by oxidative degradation as confirmed by the presence of a carbonyl band at $\sim 1740 \text{ cm}^{-1}$:

Figure 6- ATR-FTIR scans of pristine polypropylene and a representative polypropylene explant illustrating the carbonyl (C=O) peak.⁵²

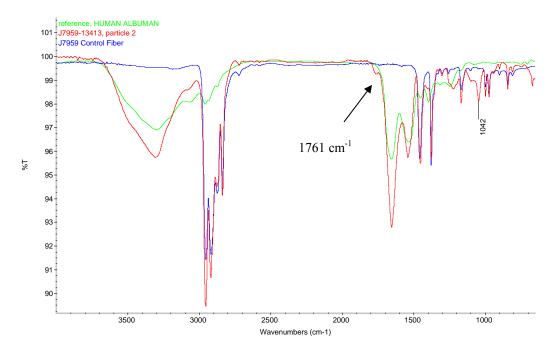
Similar to the FTIR findings in the Wood article, I have also found evidence that the Prolene in the TVT devices oxidizes which is the likely cause of the degradation and cracking observed on explanted TVT devices:

Figure 7- Overlay of FTIR spectra observed by me for explant sample 13413 particle 2 (red), human albumin (green) and control fiber lot 3422128 (blue).

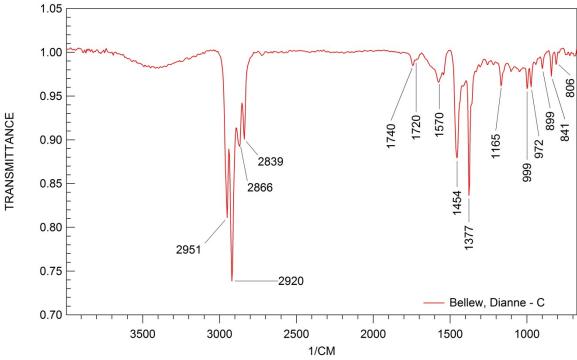
Figure 8: FTIR spectrum from an explanted Ethicon Prolift device which is also manufactured using Ethicon's Prolene polypropylene material – the same Prolene material used in Ethicon's Prosima and TVT devices (sample 35615 - C).

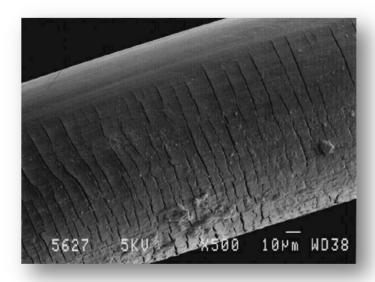
Based on my review of the scientific literature, my review of Ethicon's internal documents, including the data from the 7 year dog study and my knowledge, training and experience as a polymer scientist, it is my opinion to a reasonable degree of scientific certainty that the cracked surface of Ethicon's Prolene suture in the 7-year dog study was indeed due to degradation and oxidation. Of note, Ethicon's SEM images of the dog suture showed similar degradation and cracking reported in the scientific publications and is consistent with the degradation and cracking I have observed in my own experience analyzing degraded polypropylene, including the Prolene TVT and Prolift devices manufactured by Ethicon. [See images below] ⁶⁰

Figure 9- SEM image of suture explanted from a dog by Ethicon.

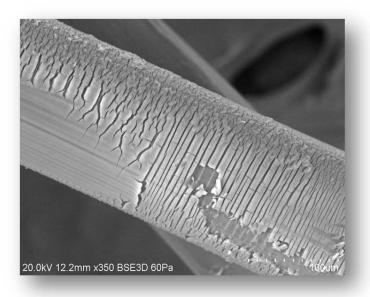
Figure 10- SEM image of explanted TVT device (Sample J7959 A13418)

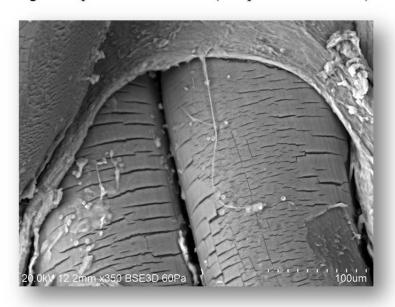
Figure 11- SEM image of explanted TVT device (Sample J7959 13405)

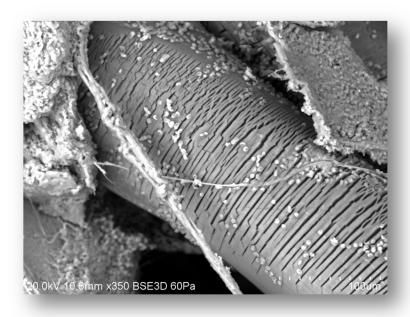
Figure 12- SEM image of explanted TVT device (Sample J7959 13407)

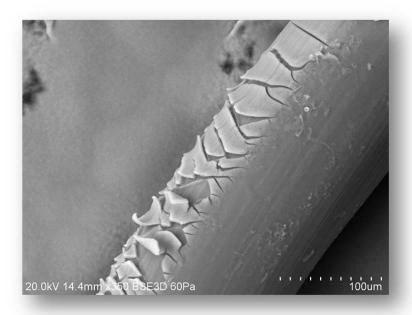
Figure 13- SEM image of explanted TVT device (Sample J7959 13403)

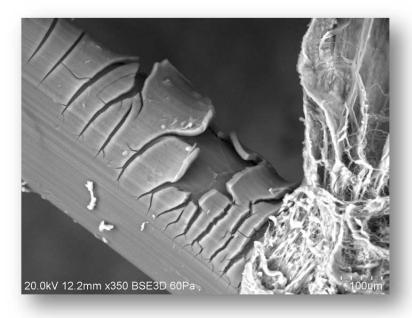
Figure 14- SEM image of explanted TVT device (Sample J7959 13409)

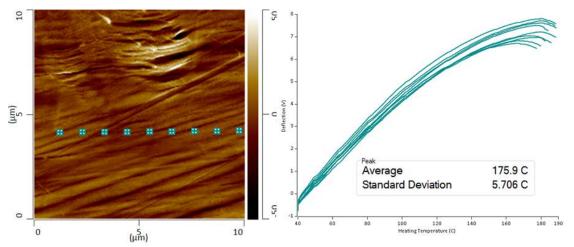
Figure 15 - AFM height image of sample surface of Exemplar A (left). nanoTA measurements obtained from surface of Exemplar A (right).

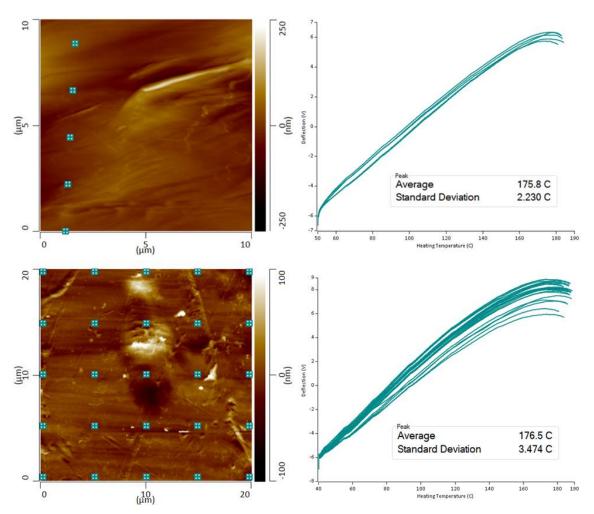
Figure 16 - AFM imaging of Exemplar C (markers on image indicate regions for subsequent nanoTA measurements (left). nanoTA measurements obtained on the surface of Exemplar C (right).

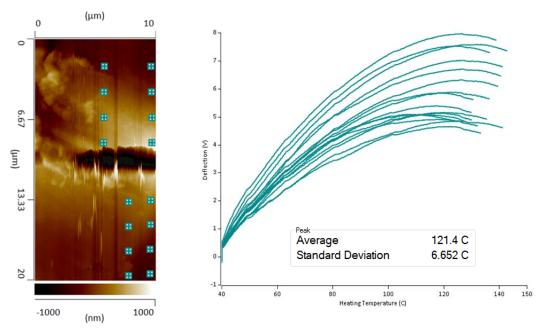
Ethicon's findings above are consistent with my own experience using melt point methods to analyze explanted Ethicon Prolene mesh devices. I have observed lower melt points using Nanothermal analysis which demonstrated that the explanted device degraded as a result of oxidation, which most likely occurred as a result of *in vivo* leaching of the antioxidants which leaves the Prolene fibers unprotected against oxidation.

Figure 17 - AFM image of cracked region on Bellew, Dianne B (left). nanoTA measurements obtained around cracked regions on Bellew, Dianne B (right).

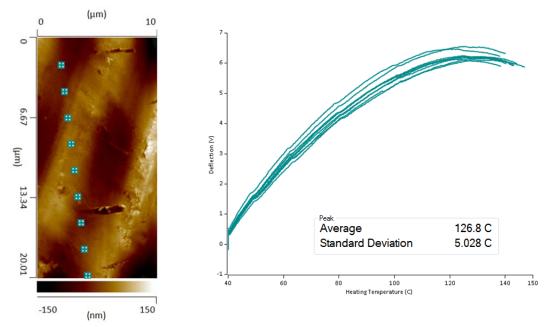
Figure 18 - AFM height image showing surface topography of Bellew, Dianne B fibers in region away from cracks (left). nanoTA measurements obtained away from the cracked regions on Bellew, Dianne B fibers (right).

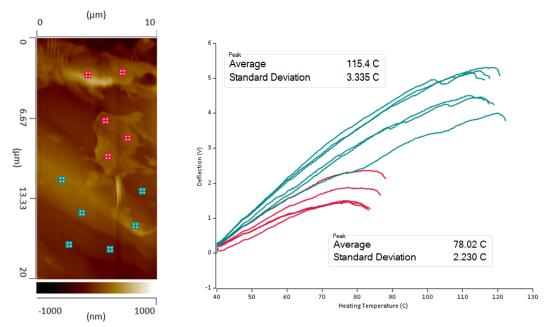
Figure 19 - AFM height image of surface of hypochlorite treated Bellew, Dianne C (left). nanoTA measurements on Bellew, Dianne C both on (red) and off (blue) the flake-like material (right).
